**Closed
Landfill
Program**

Annual Report 2003

**Washington
County
Sanitary
Landfill**

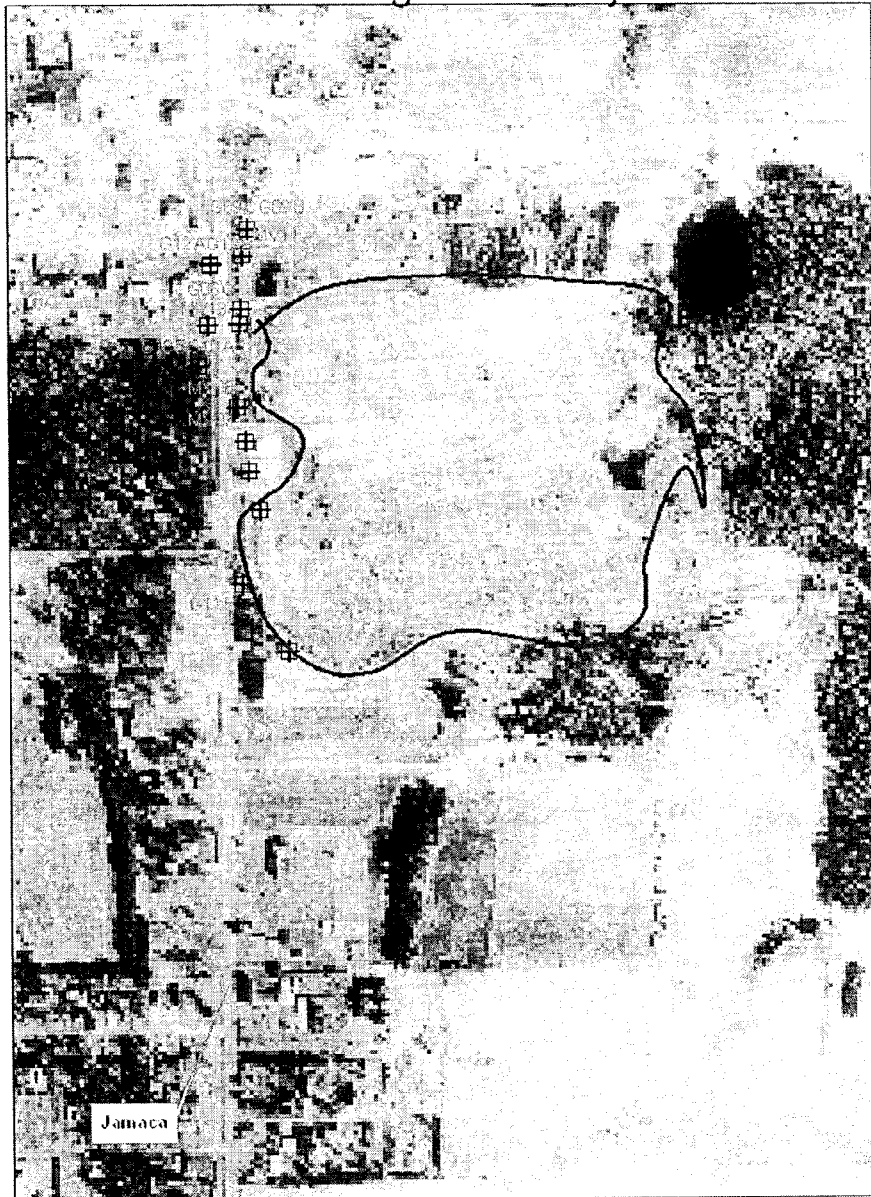
Figure 1 Gas Probe Monitoring Network
around Washington County Landfill

There are 27 gas monitoring points to monitor for the presence of landfill gas generated by the Washington County Sanitary Landfill. Landfill gas migration was controlled adequately by the active gas extraction system. Table 1 summarizes the results of operating the flare including the hours the flare ran for the past two years. The flare has operated 95 percent of the time in the last year. Table 2 summarizes methane readings collected in 2003 in the gas. The Operation and Maintenance contractor, Conestoga-Rovers & Associates (CRA), monitors the probes quarterly. Methane was not detected in the probes in 2003.

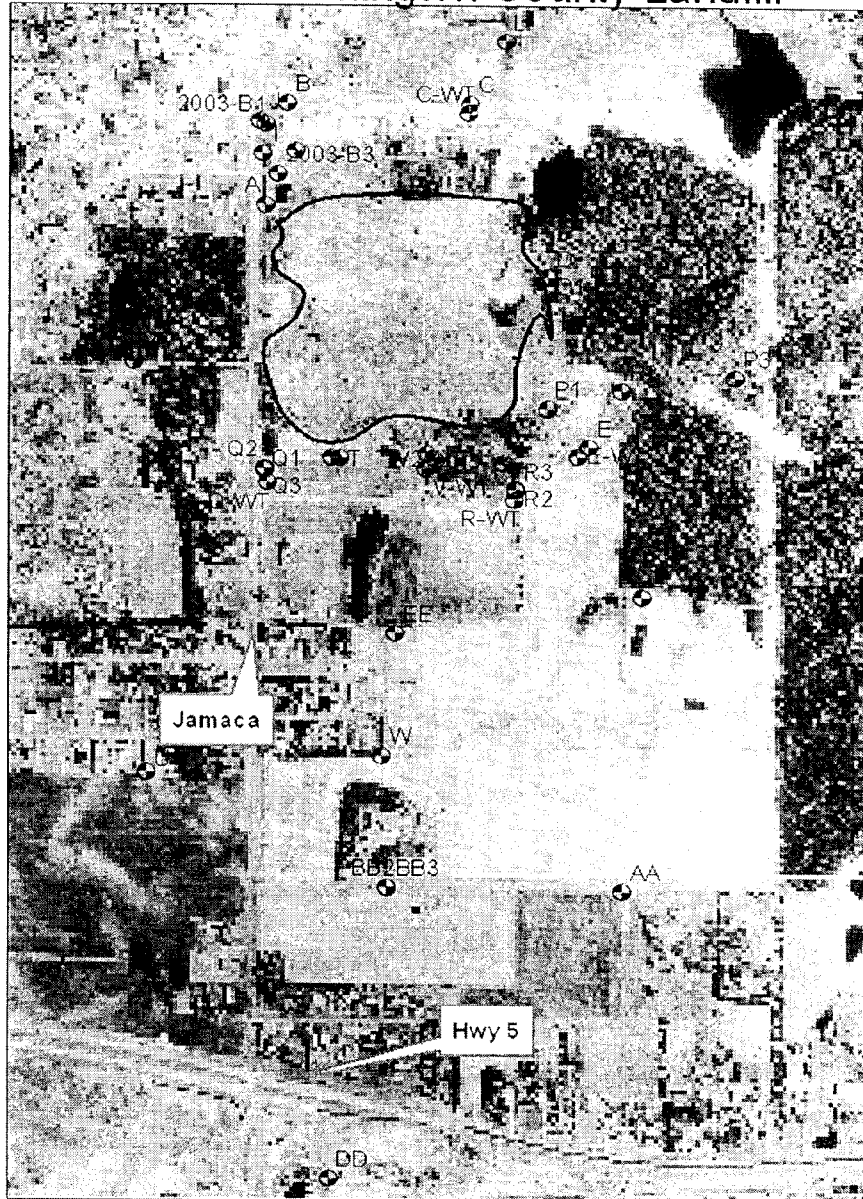
Figure 2 Groundwater Monitoring Network around Washington County Landfill

by Interpoll Laboratories, Inc. (Interpoll) collected 3 rounds of water quality samples in 2003 at the Washington County Landfill. The landfill monitoring system consists of 38 wells and 1 surface water sampling points. The Environmental Monitoring System includes 38 monitoring wells. Of these, 10 wells are located in an upgradient direction, 23 are downgradient and 5 are sidegradient. A map showing the locations of each of the monitoring points is presented in Figure 2. A list of the wells and dates sampled during 2003 is included in Table 4.

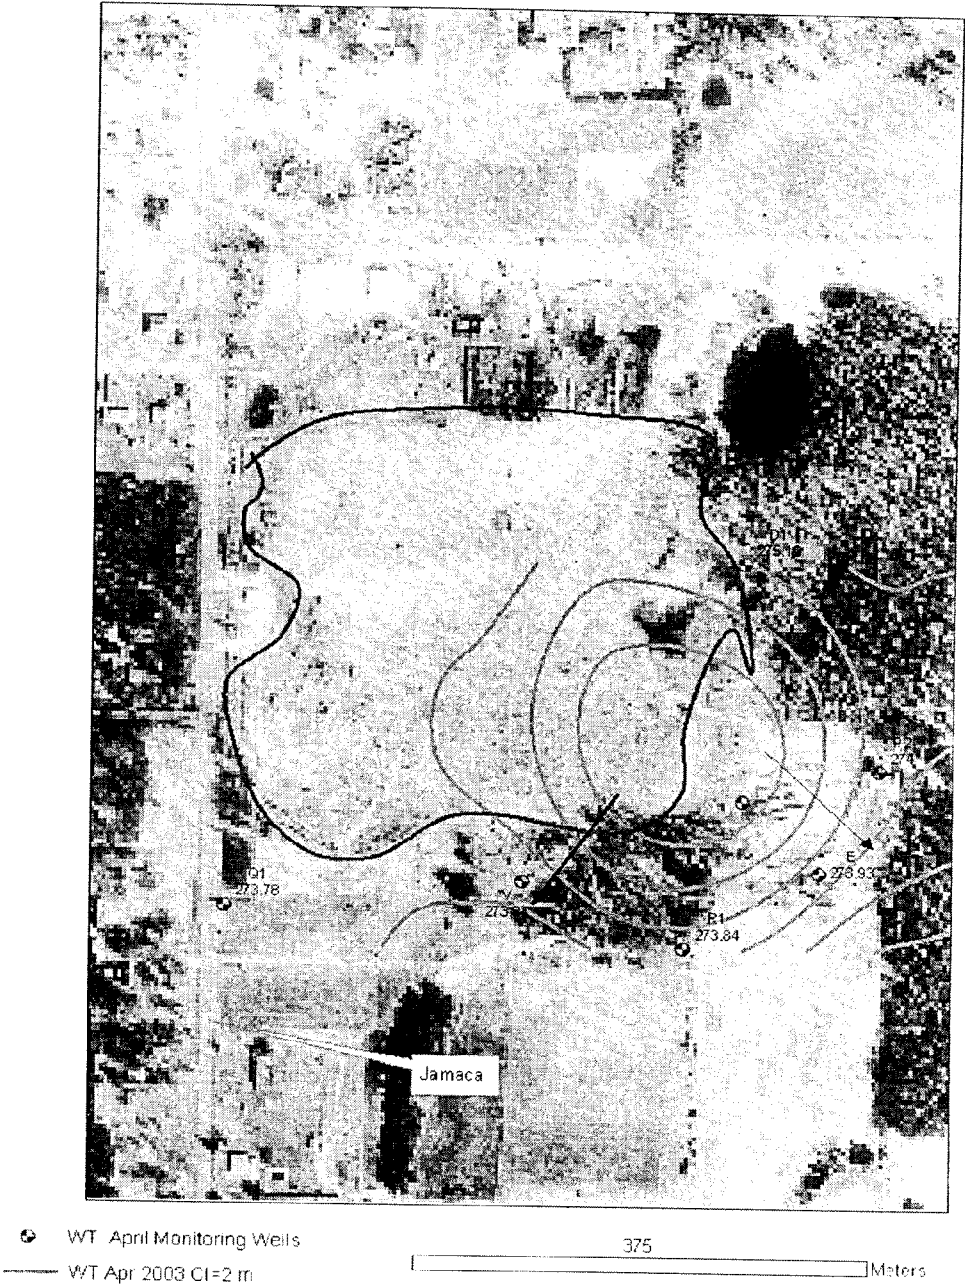
Figure 3 Flow in the Surficial Aquifer, April 2003

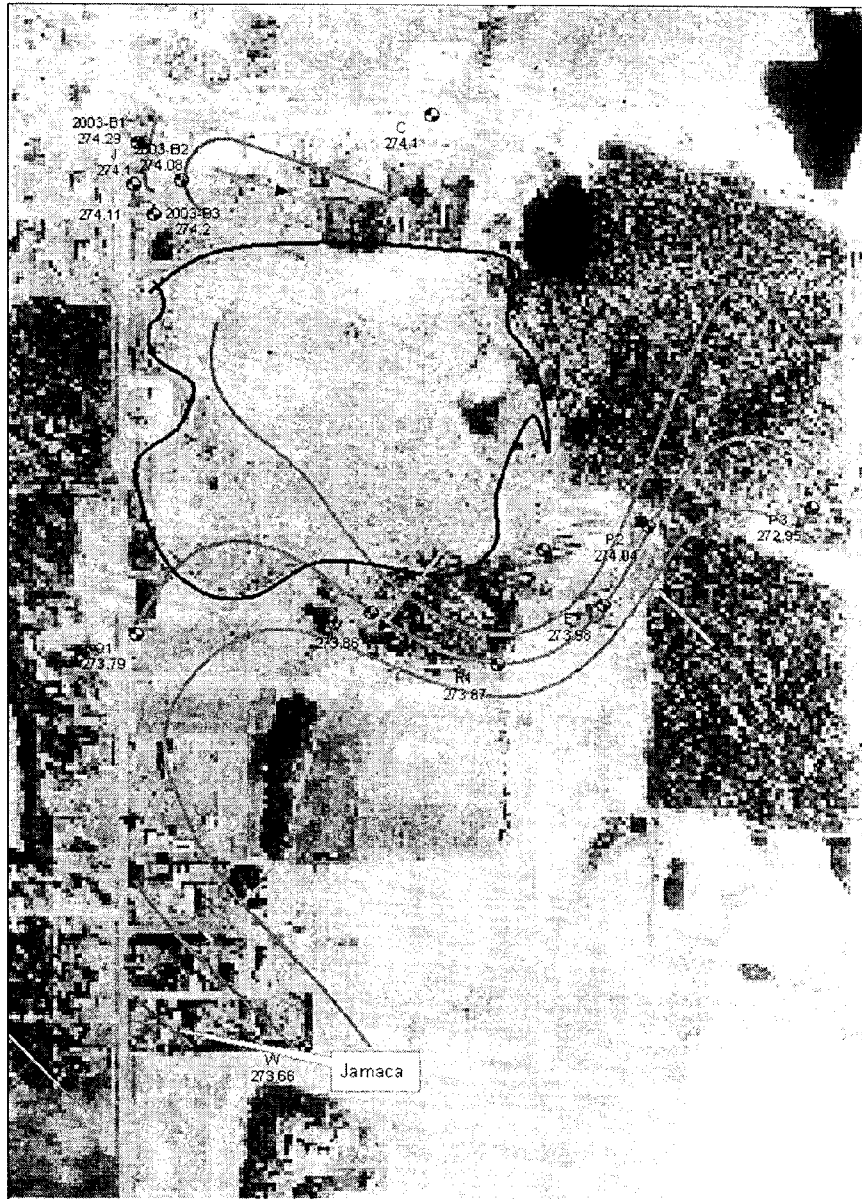
Figure 4 Flow in the Surficial Aquifer, July 2003

— WT July 2003 CI=2 m
● WT July MWs

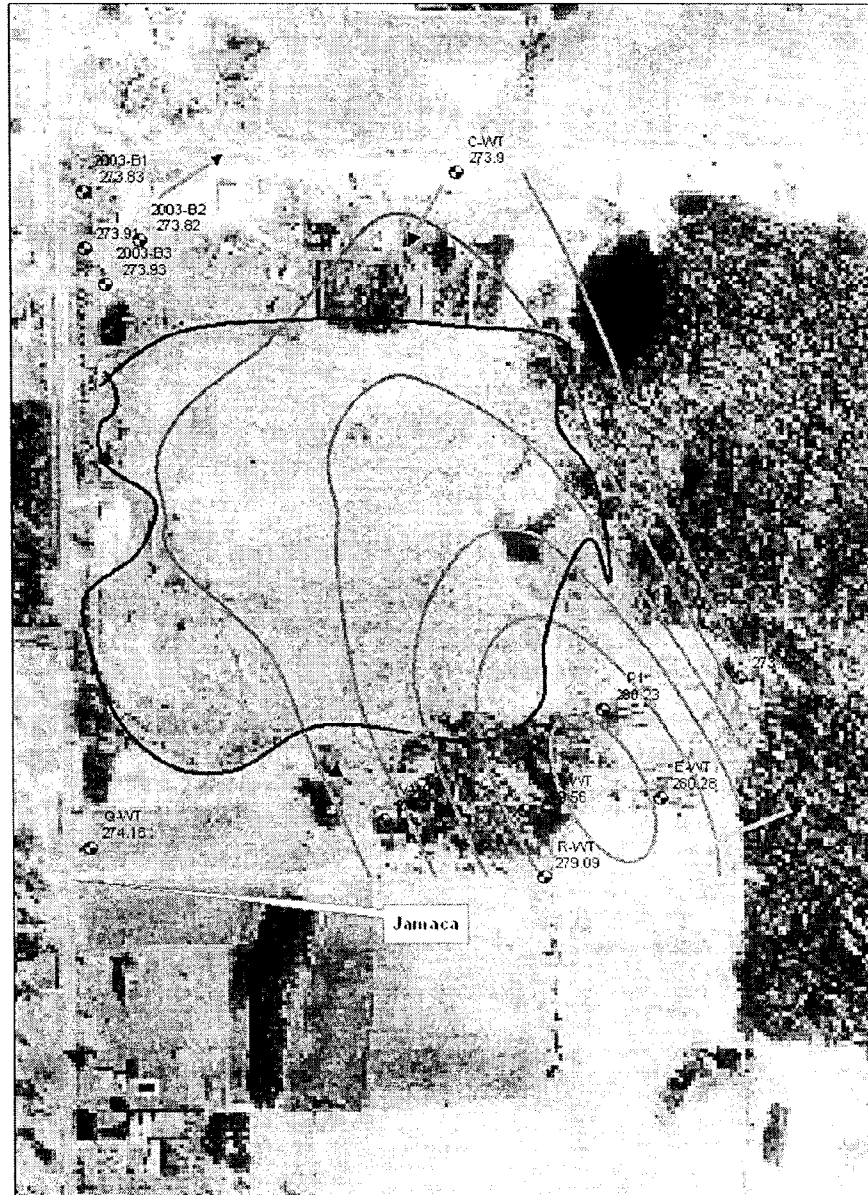
Figure 5 Flow at the water table
October 2003

— WT Oct 2003 CI=1.5 meters
 ● Wells Oct 2003

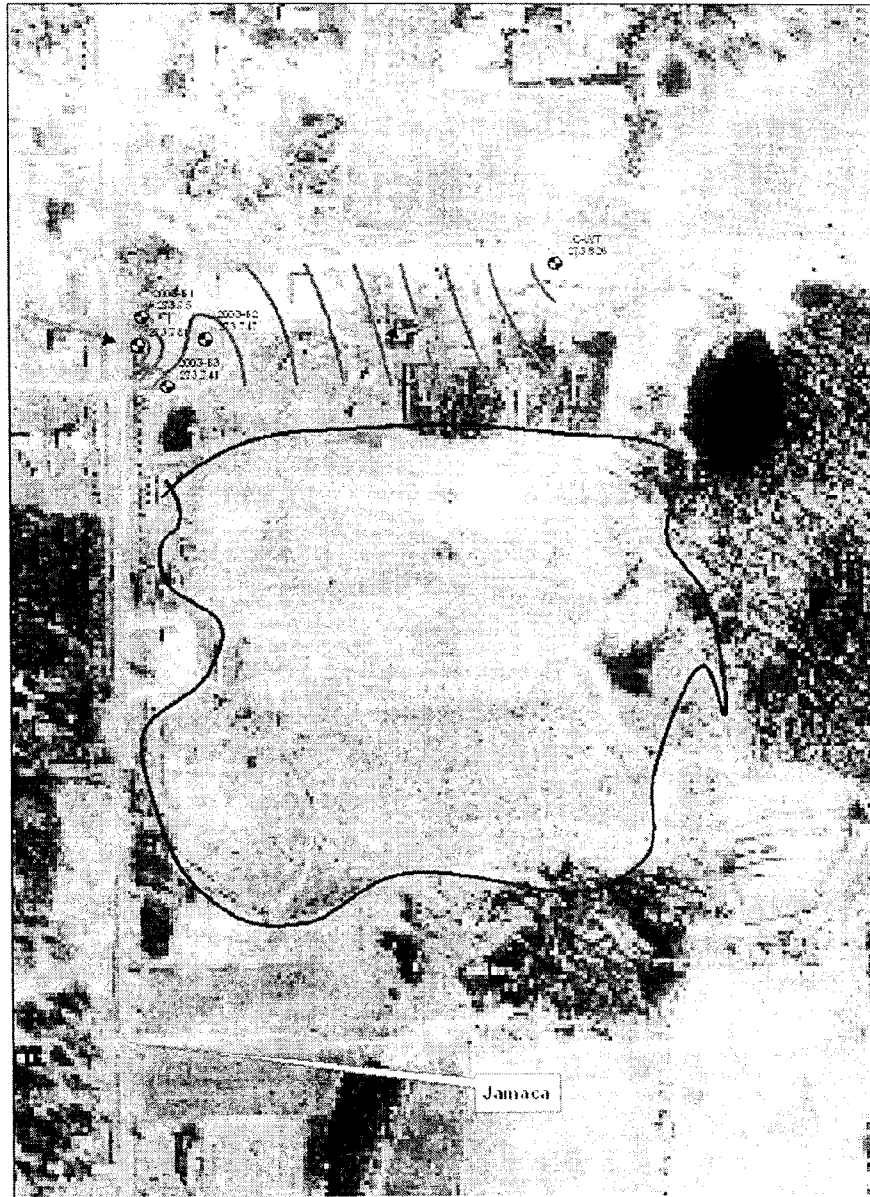
Figure 6 Flow at the water table north of the site
December 2003

— North WT Dec 2003 CI=0.01 m

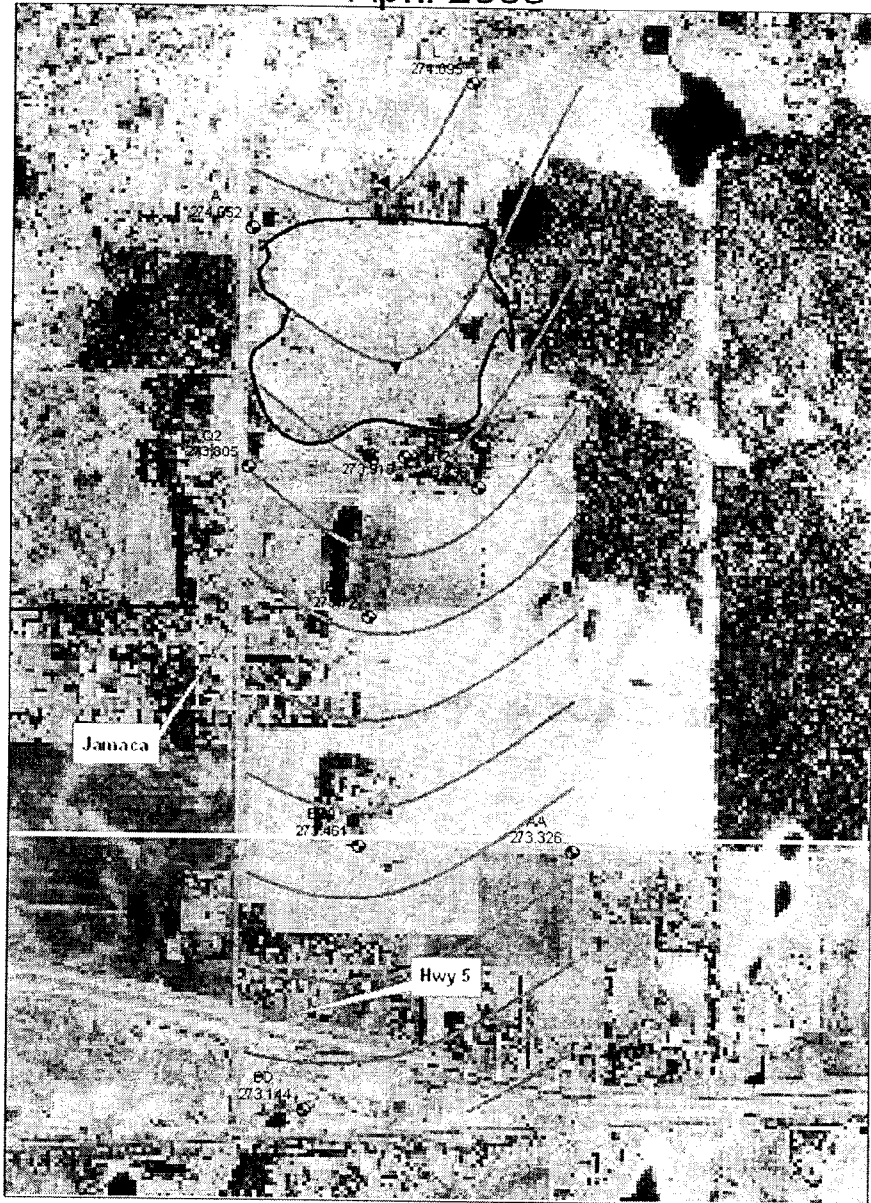
Figure 7 Flow at the base of the surficial aquifer
April 2003

Basal Aquifer wells
Base of surficial aquifer, C1=0.1

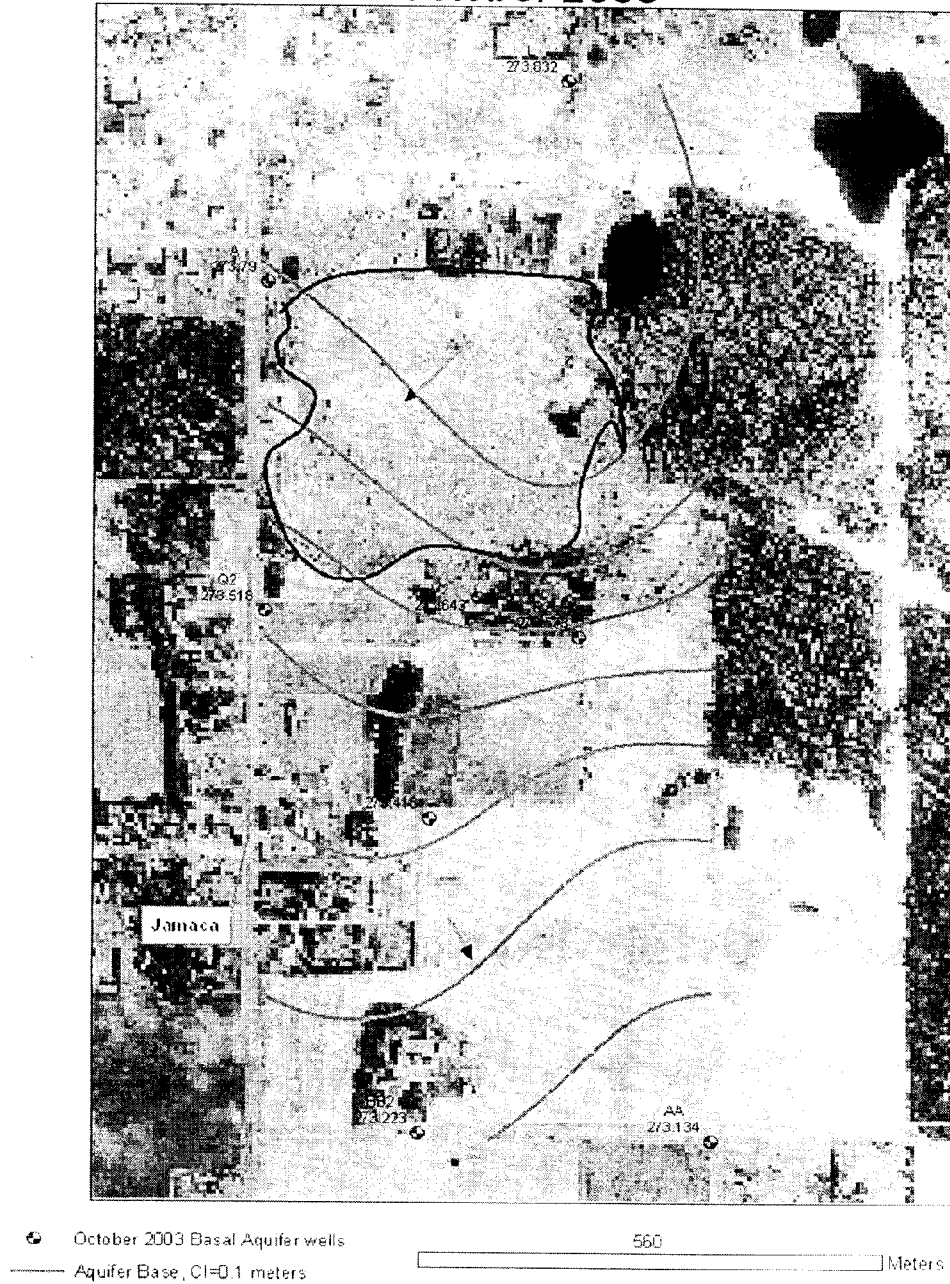
Figure 8 Flow at the base of the surficial aquifer
October 2003

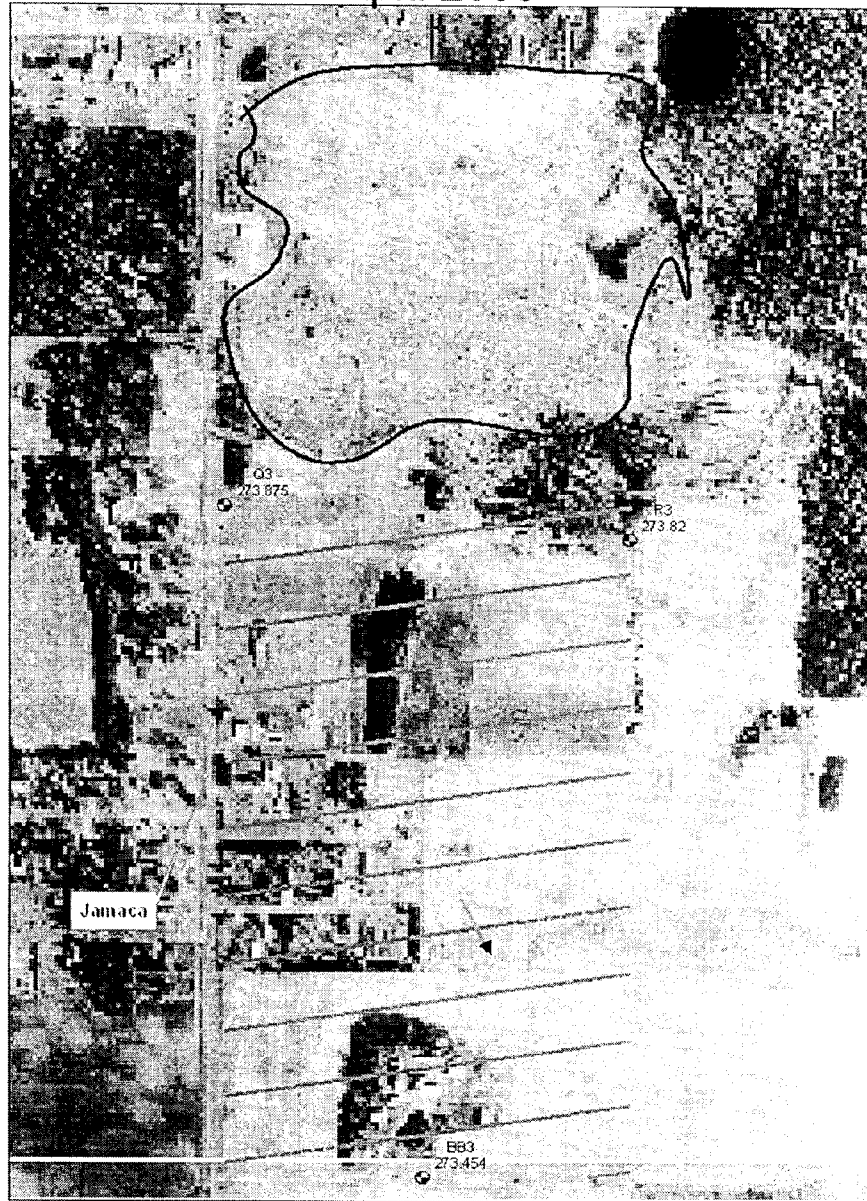
Figure 9 Flow in the Prairie du Chien aquifer
April 2003

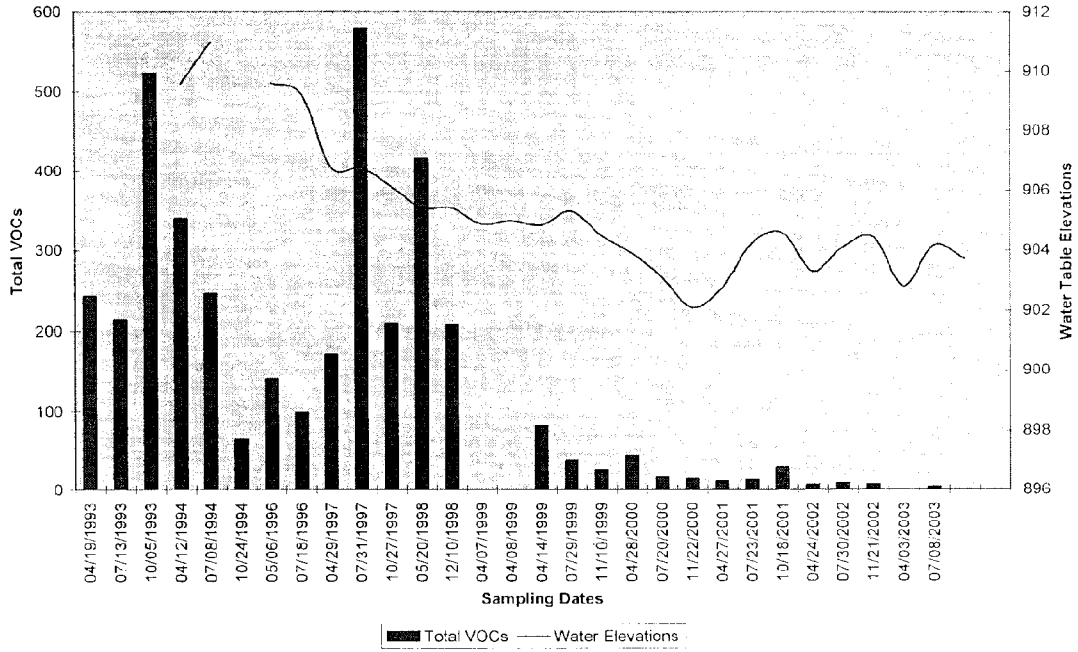
Figure 10. Washington County Sanitary Landfill
 VOCs vs. Water Table Elevations - Well D1

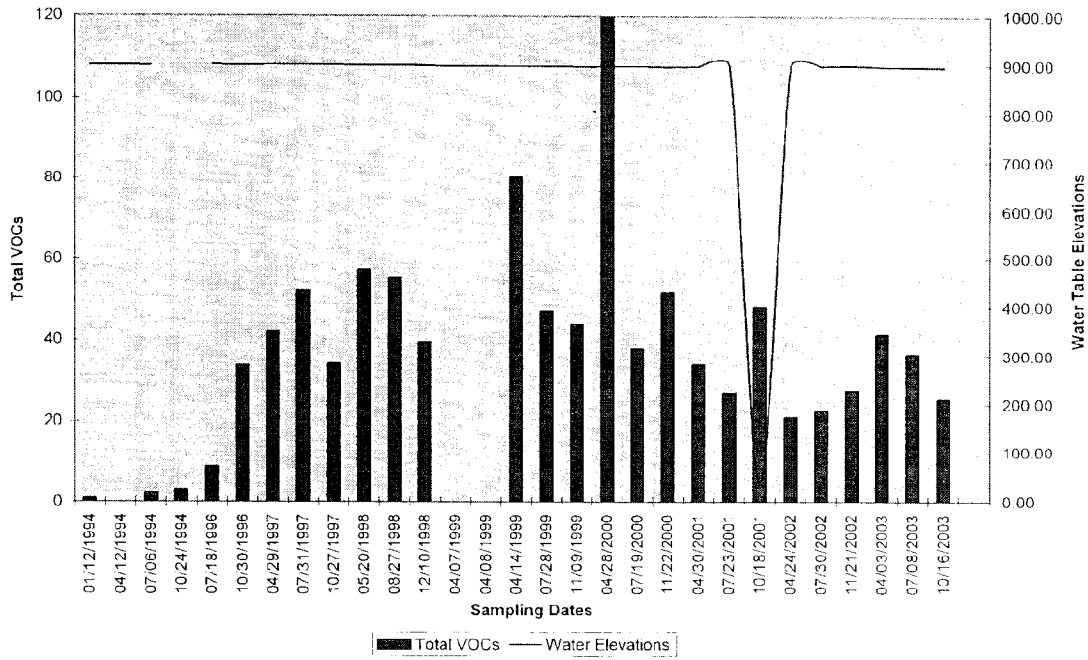
Figure 11. Washington County Sanitary Landfill
 VOCs vs. Water Table Elevations - Well EE (Deep)

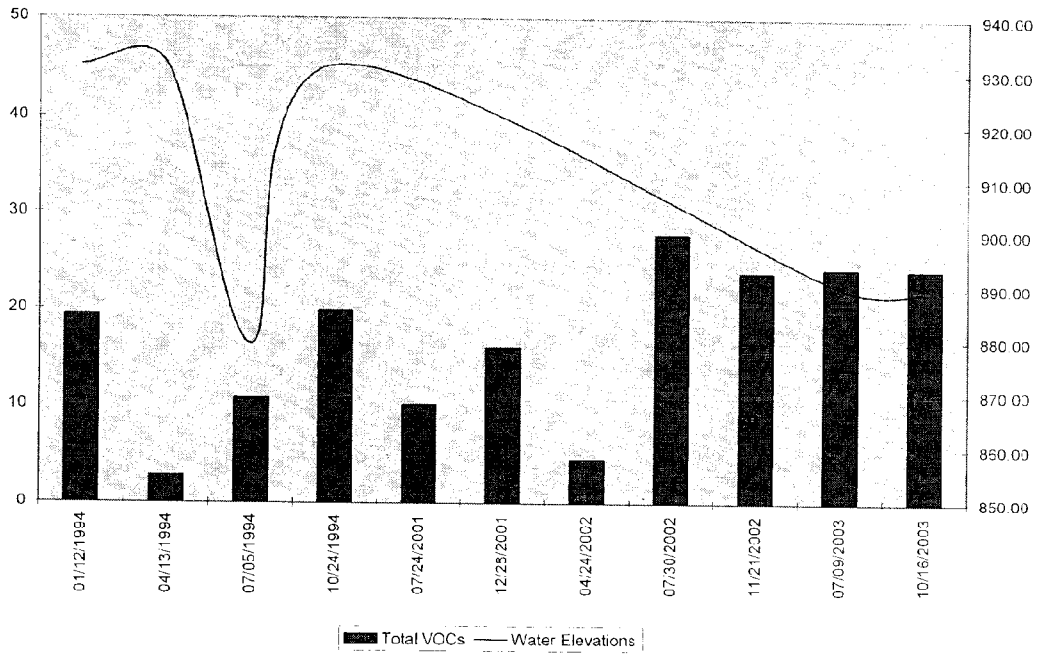
Figure 12. Washington County Sanitary Landfill
 VOCs vs. Water Table Elevations - Well GC-1 (Gradient Control)

A graph of total volatile organic compounds in the gradient control well indicates several things (see Figures 12). The trend observed at GC-1 (shown in Figure 12) indicates increasing contamination with increasing ground water elevation for data through 2003. This may reflect capture in the gradient control well. A graph at EE can be used as a measure of the behavior of wells outside of the fill area and still impacted by contamination (Figure 11). The trend at EE during 2003 has been a declining trend with a small peak during the first sampling event of the year. However, the plume appears to be stable at EE because the concentration range since 2000 has been less than 50.

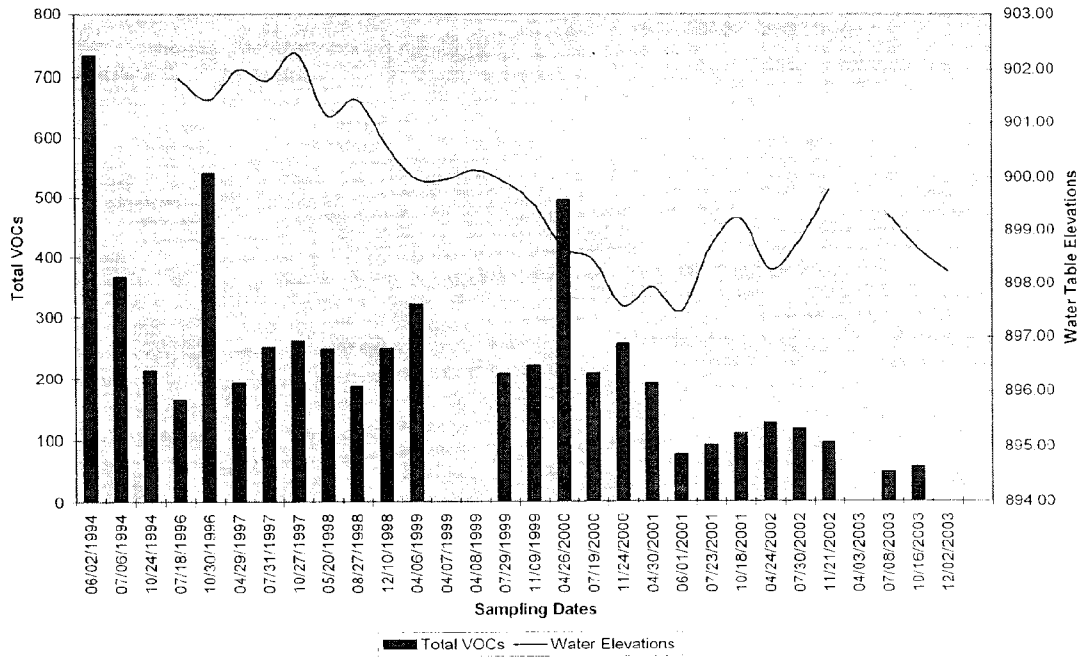
Figure 13. Washington County Sanitary Landfill
VOCs vs. Water Table Elevations - Well I

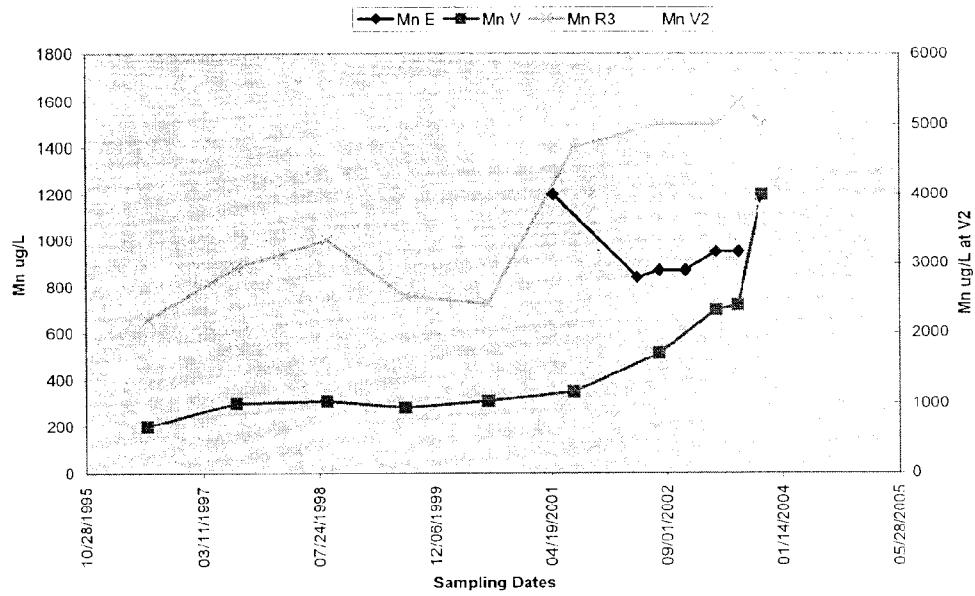
Figure 14.
Manganese at selected wells

GC-1 appears to be having an impact on the plume in the downgradient direction and may be stabilizing the plume around well EE. The concentration of manganese is problematic (Figure 14) and may be partially related to the infiltration of treated water. The gradient control well and treatment system must continue to operate to prevent the migration of a plume downgradient but a new gradient control well will be installed in 2004 to pump directly in the plume and discharged outside of the plume.

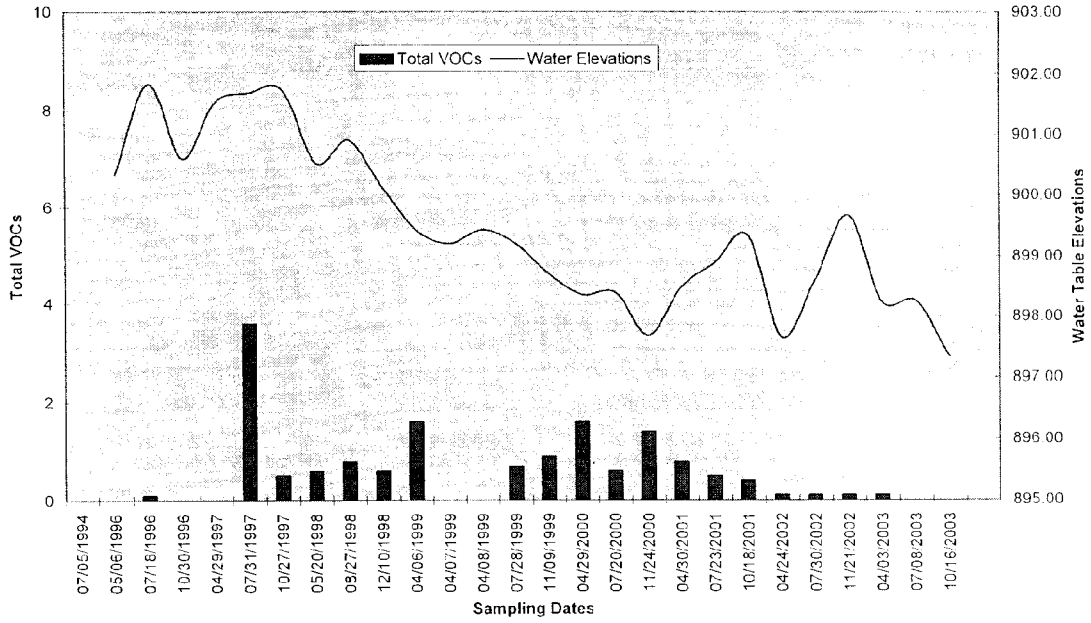
Figure 15. Washington County Sanitary Landfill
 VOCs vs. Water Table Elevations - Well Q1

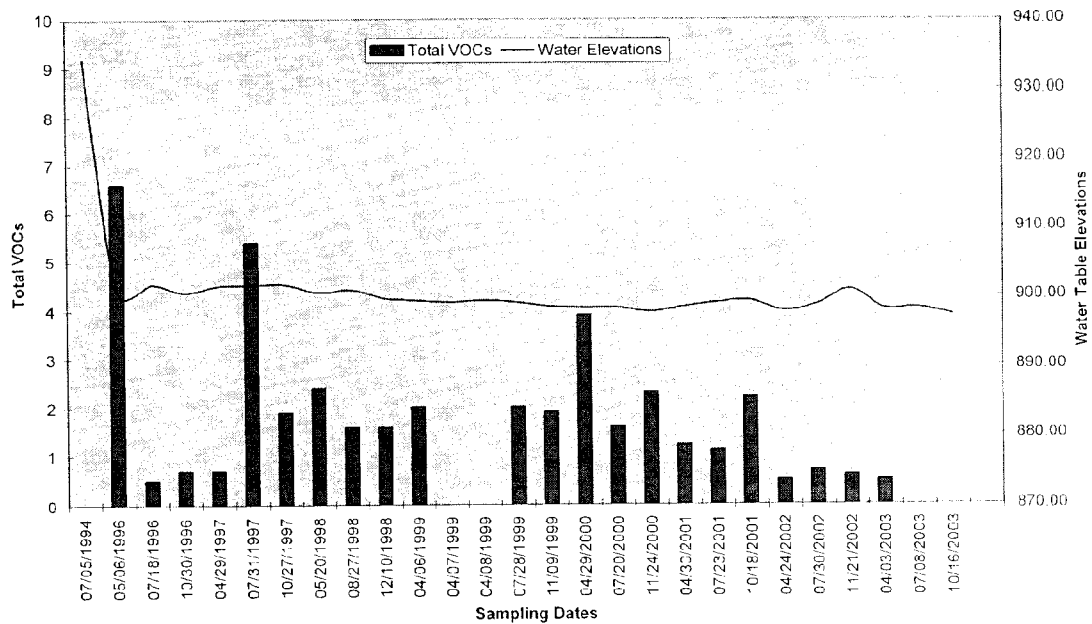
Figure 16. Washington County Sanitary Landfill
 VOCs vs. Water Table Elevations - Well Q2

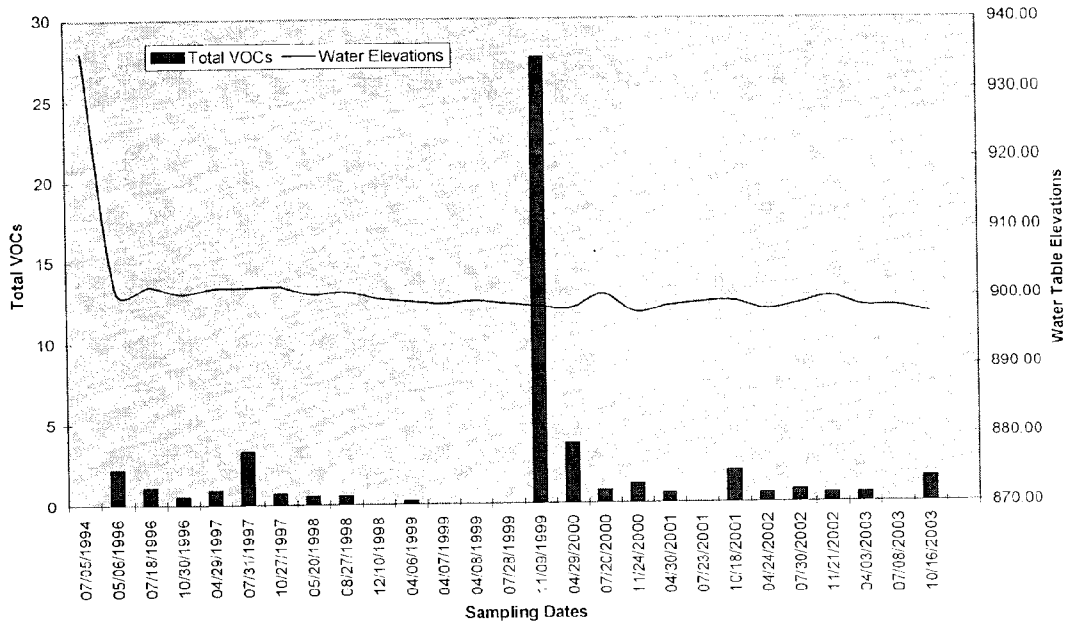
Figure 17. Washington County Sanitary Landfill
 VOCs vs. Water Table Elevations - Well Q3

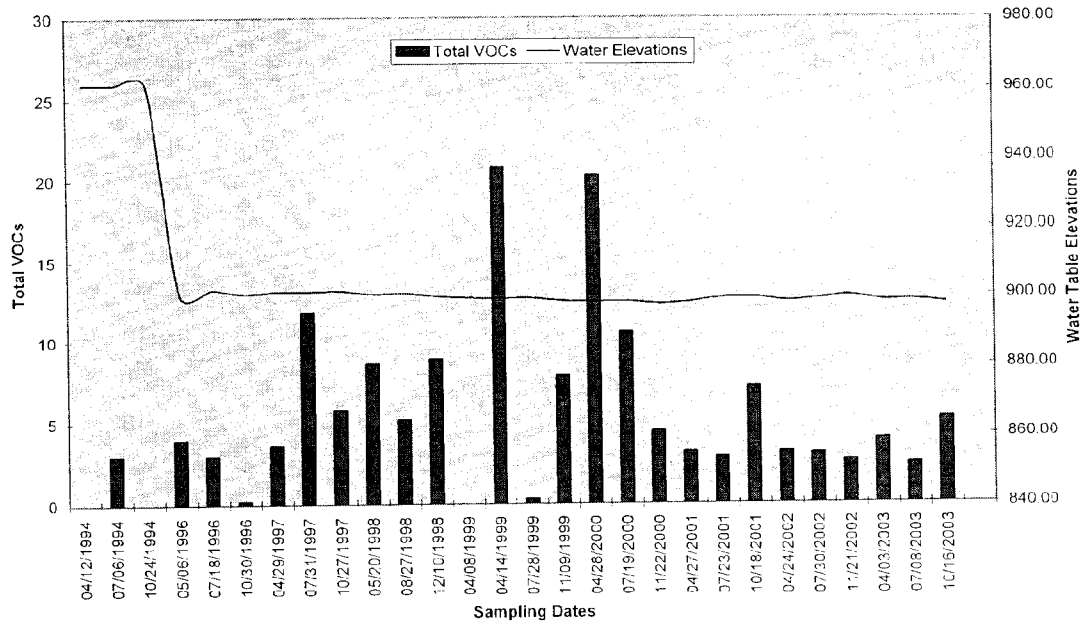
Figure 18. Washington County Sanitary Landfill
VOCs vs. Water Table Elevations - Well R1

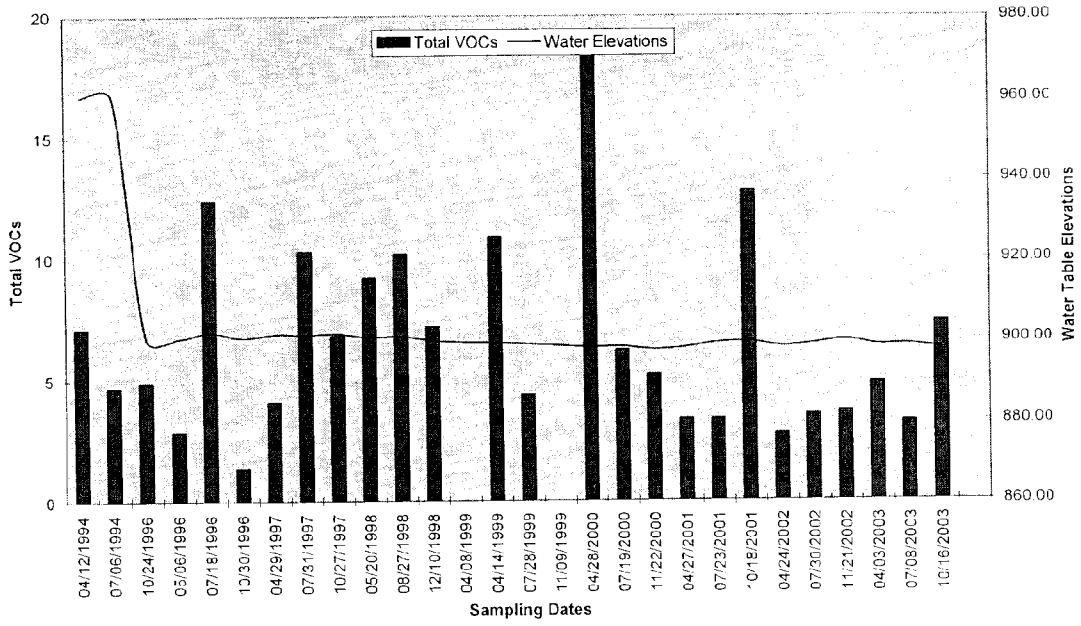
Figure 19. Washington County Sanitary Landfill
VOCs vs. Water Table Elevations - Well R2

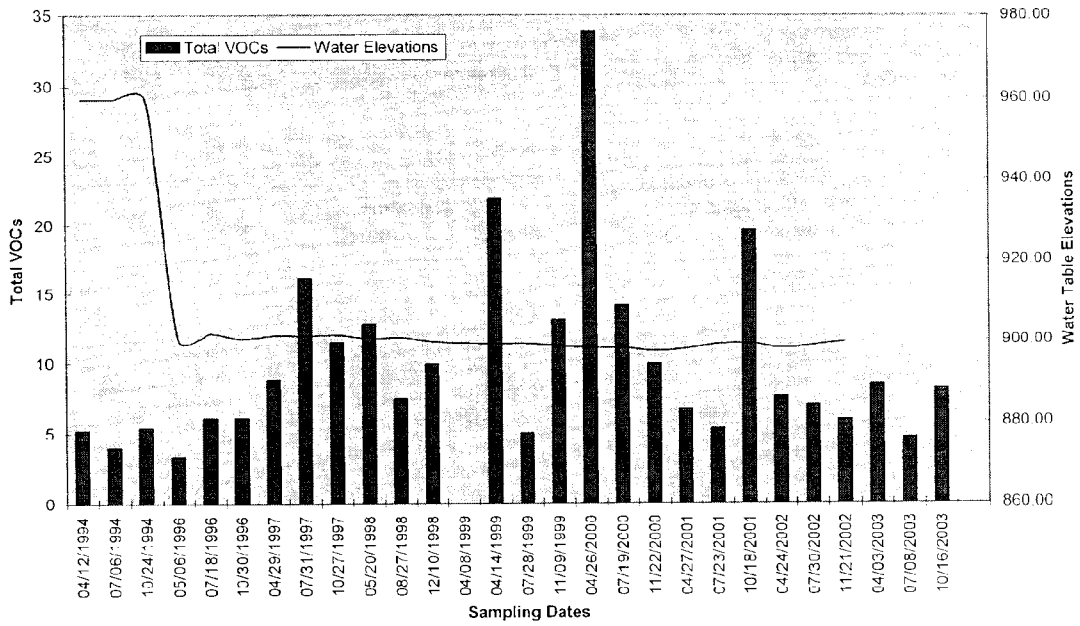
Figure 20. Washington County Sanitary Landfill
 VOCs vs. Water Table Elevations - Well R3

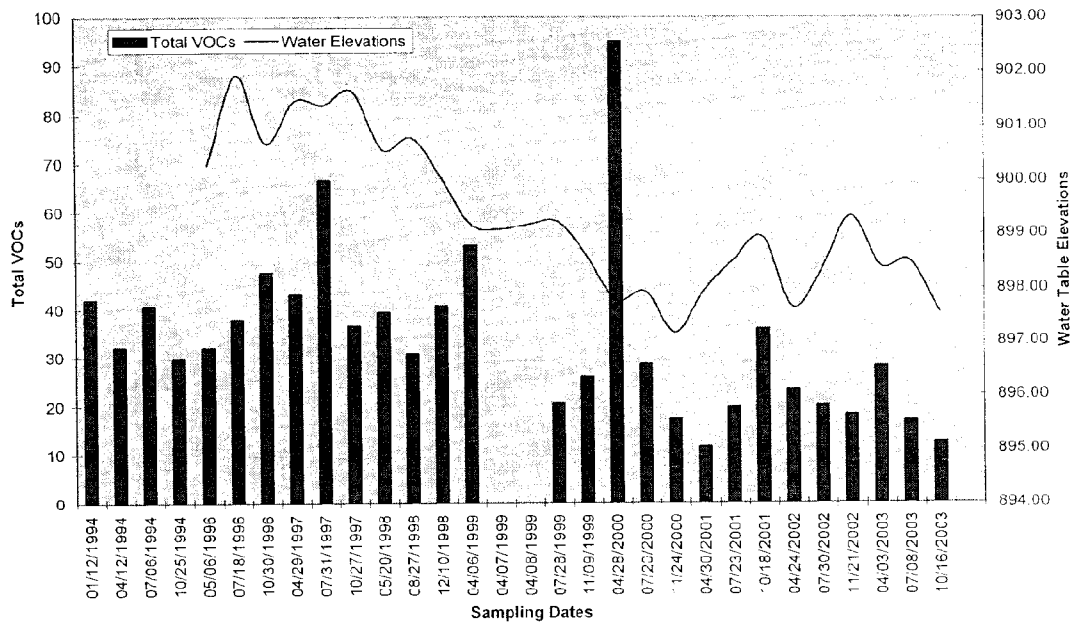
Figure 21. Washington County Sanitary Landfill
 VOCs vs. Water Table Elevations - Well V

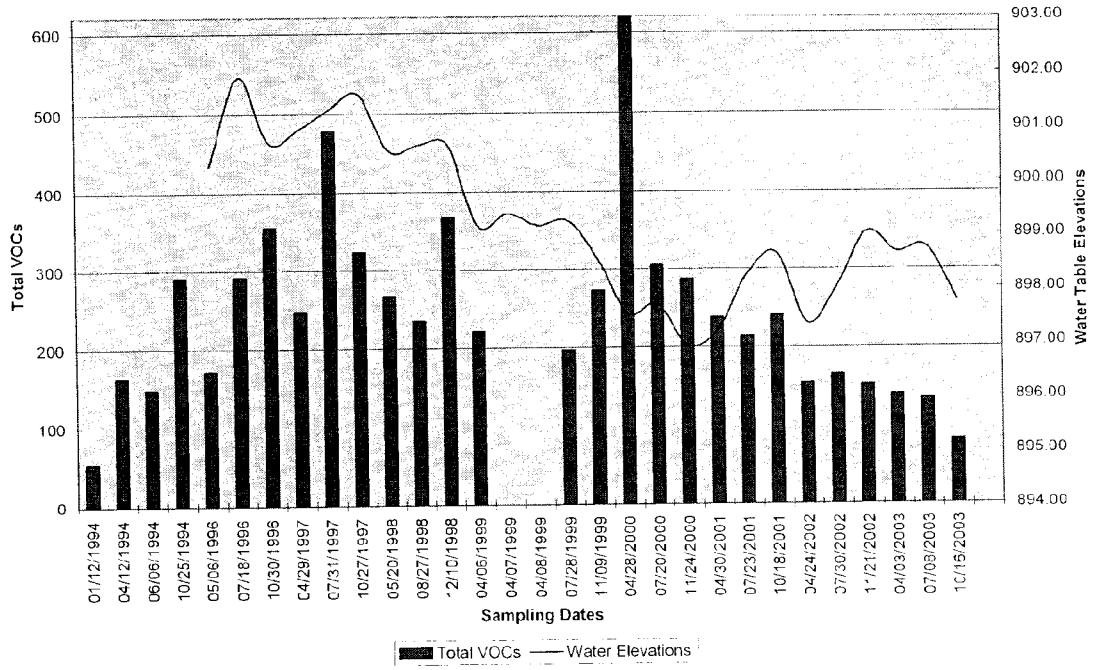
Figure 22. Washington County Sanitary Landfill
 VOCs vs. Water Table Elevations - Well V2

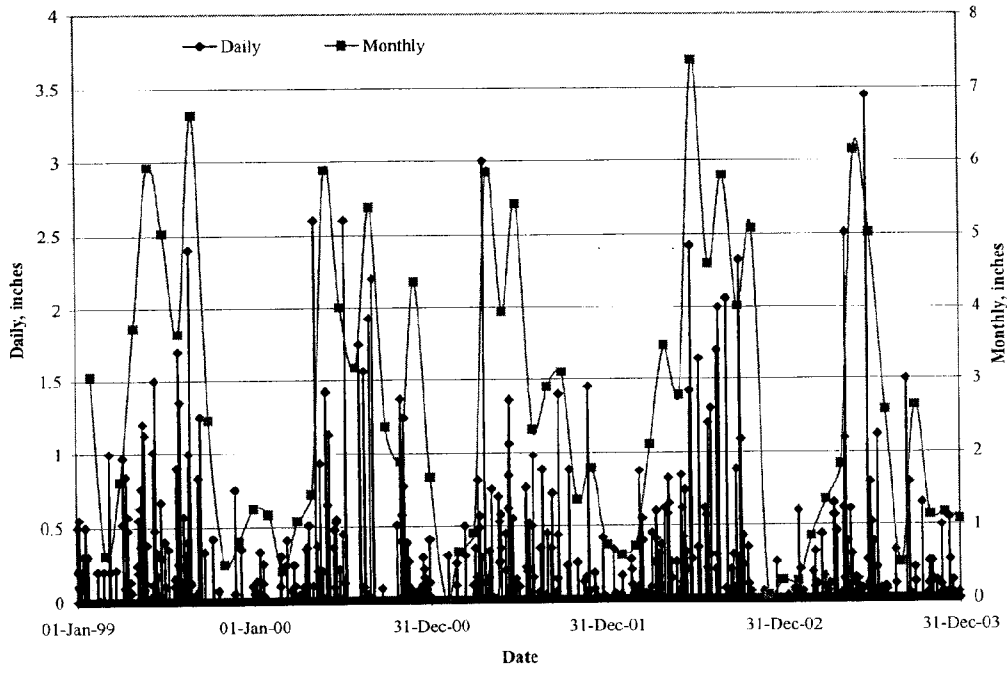
Figure 23. Daily and Monthly Precipitation around Washington County Landfill-1999 to 2003
